Case Study: Non-Destructive Testing (NDT) of steel slab corrosion under bituminous underlay and vinyl tiles

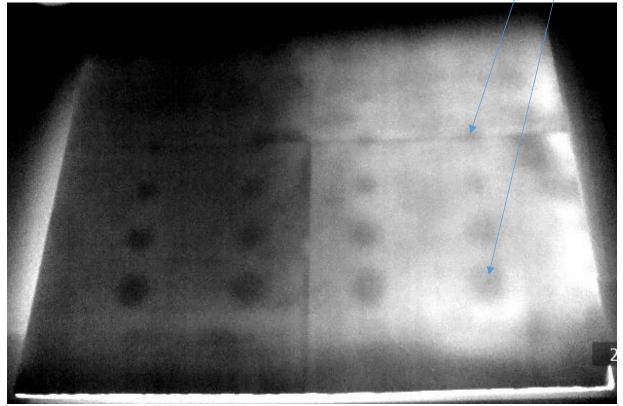
Example 1: Steel Slab Inspection from the Vinyl Tiles side. The inspection targets flat bottom holes that simulate the reduction of steel due to corrosion **between** the underlay and the steel slab. These holes have varying internal diameters, ranging from 1.5" (38mm) down to 3/4" (19mm). The thickness of the steel removed to simulate corrosion ranges from 3/32" (2.4mm), representing 50% corrosion, down to 1/32" (0.8mm), indicating 15% corrosion of the original 3/16" (4.8mm) thick steel slab. The overall thickness of the bituminous underlay and vinyl tiles varies between 3/8" (9.5mm) and 5/8" (15.9mm):

Top view CAD showing the FBH in the steel :

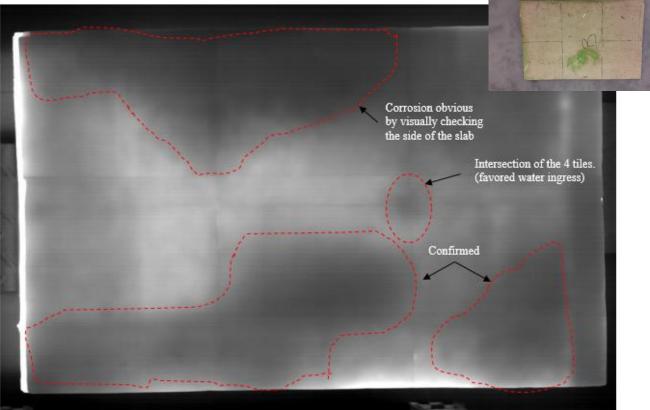
Corresponding Infrared Thermography (IRT) View through the Vinyl Tiles and Underlay:

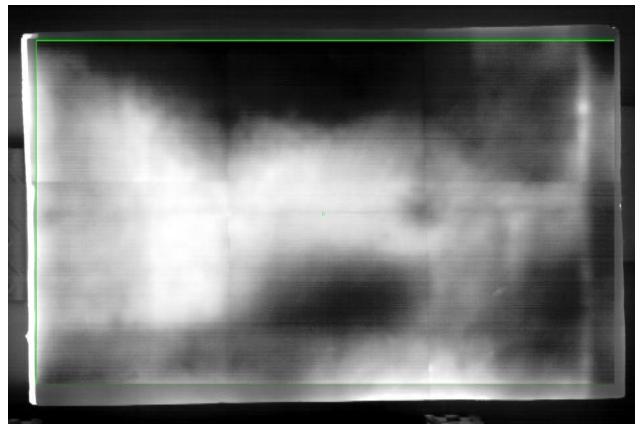
Example 2: real case of corrosion detected on a 3/16" (4.8mm) thick steel slab. The corrosion was observed through approximately 1/2" (12.7mm) of bituminous underlay and vinyl tiles:

Image with improved contrast below, the black areas indicate loss of steel material or corrosion:
