Eddy Current Thermography heating on:

Plate : 444 mm (17.5 in) x 762 mm (30 in);

Paint thickness = 0.45 mm (1/64 in)

Plate thickness = 6.35 metal + 0.45 mm paint = 6.8 mm (1/4 in + 1/64 in = 17/64 in)

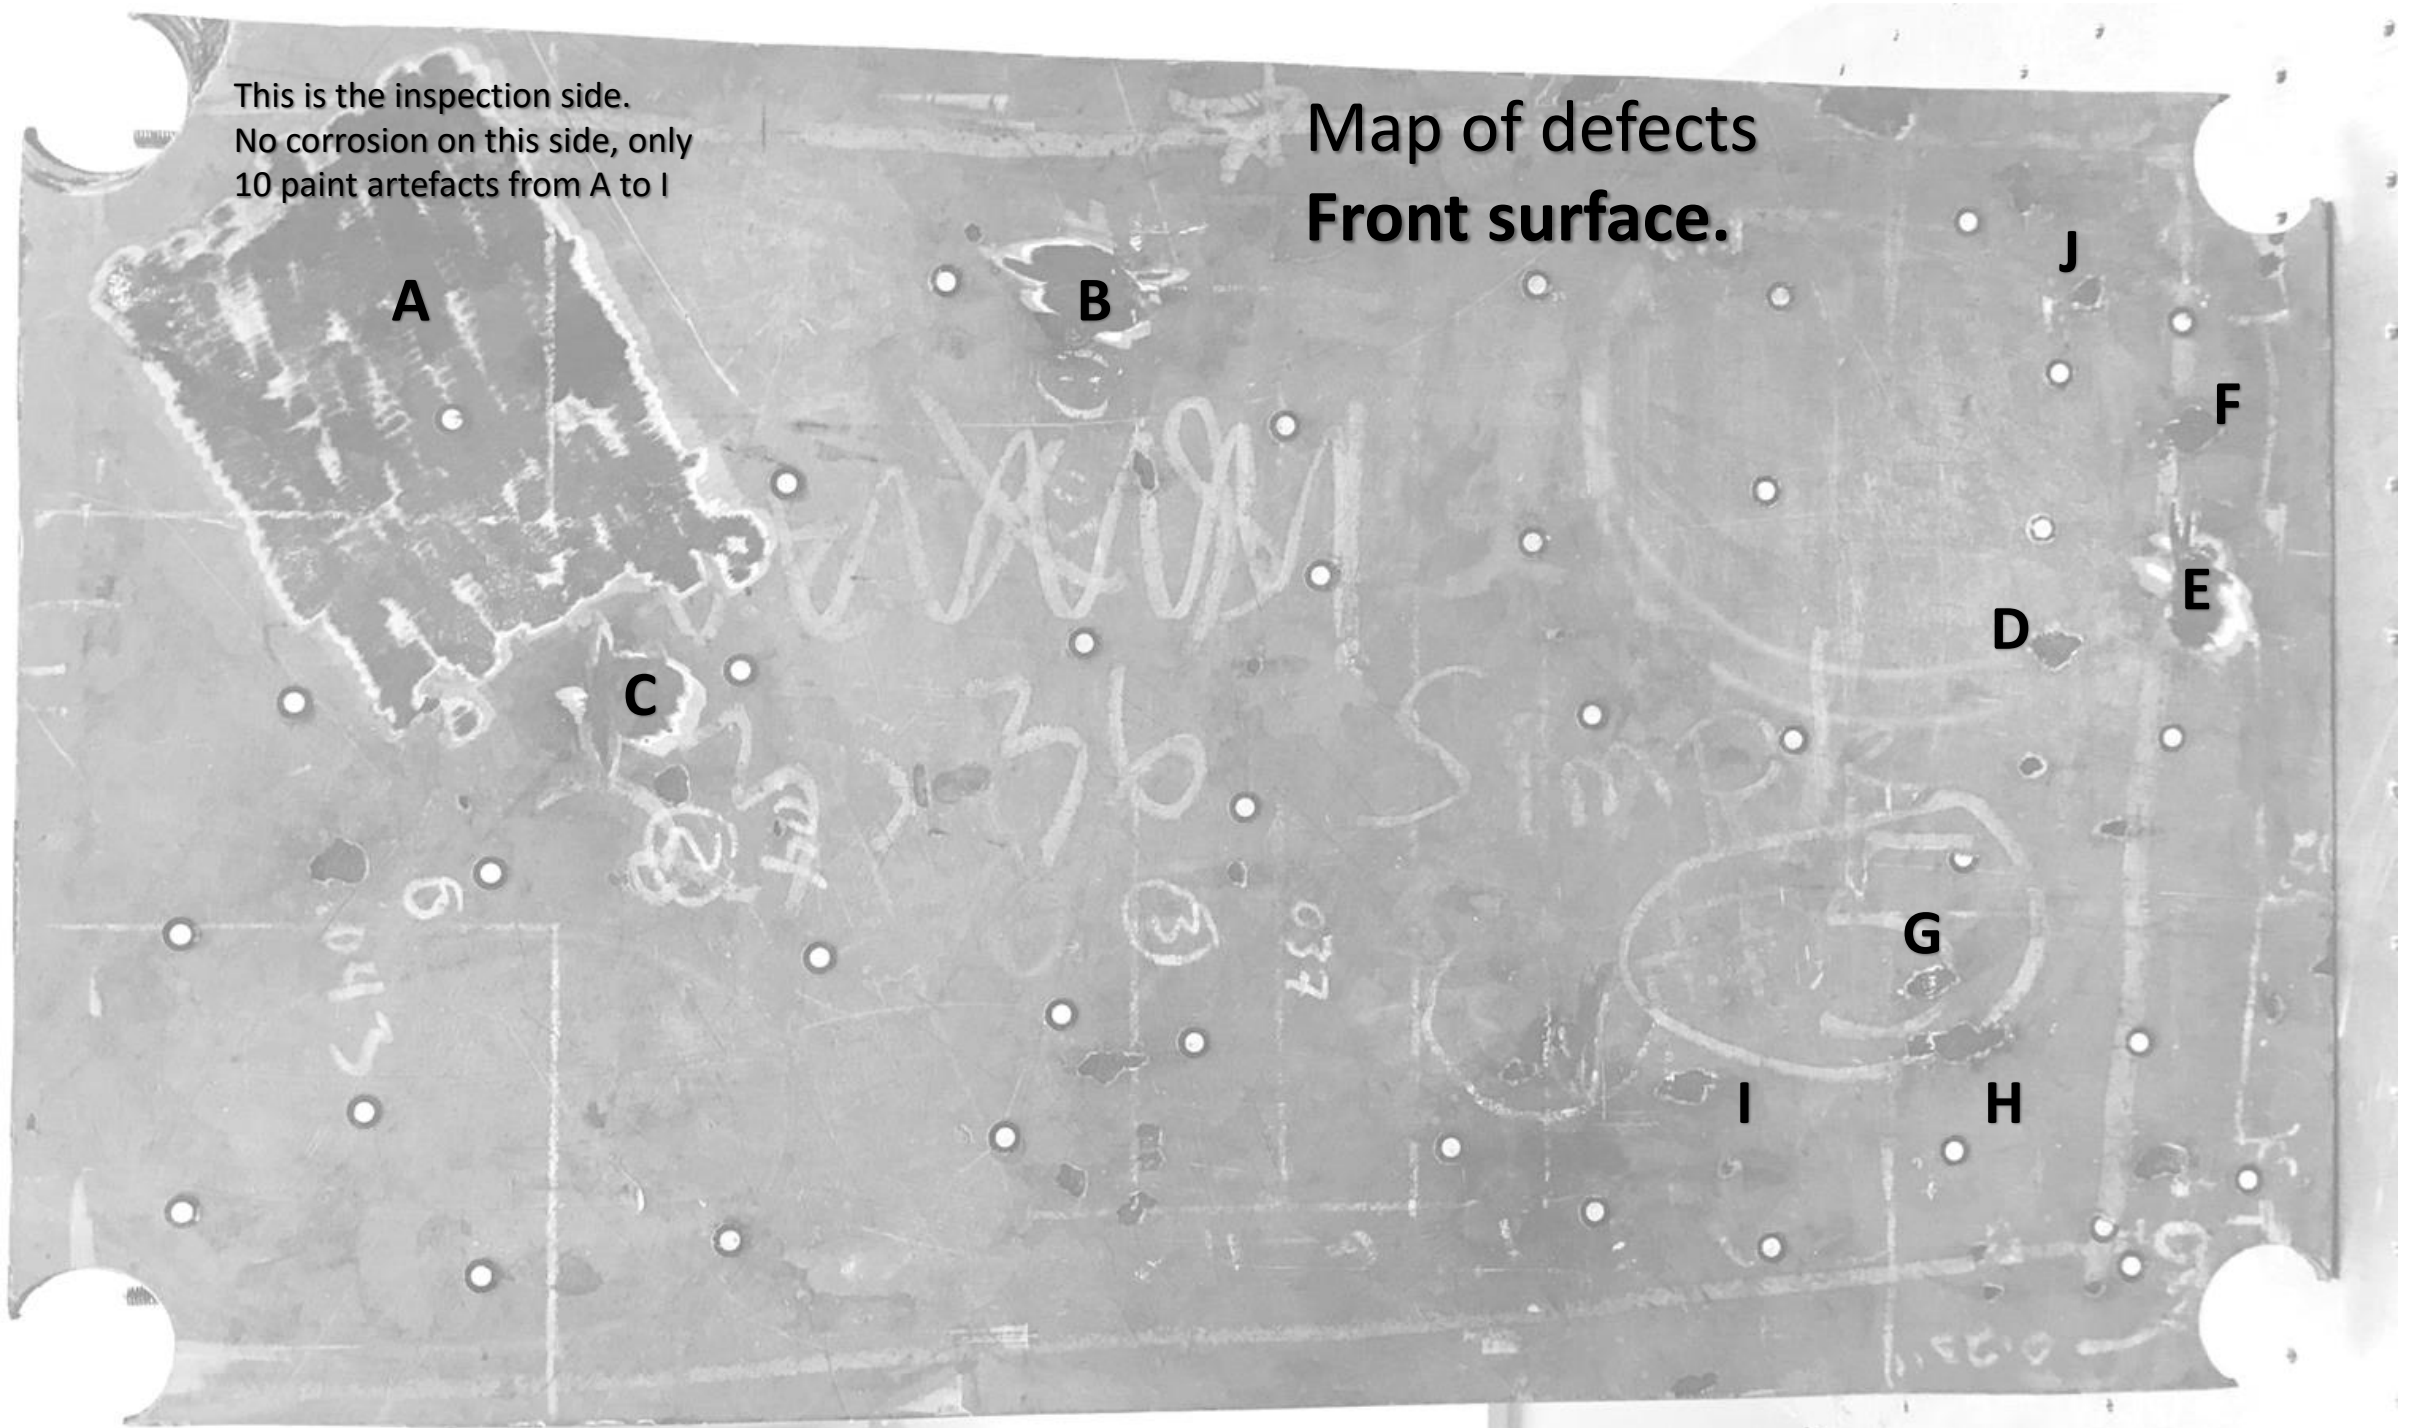
Map of defects
Front surface.

This is the inspection side.
No corrosion on this side, only
10 paint artefacts from A to I

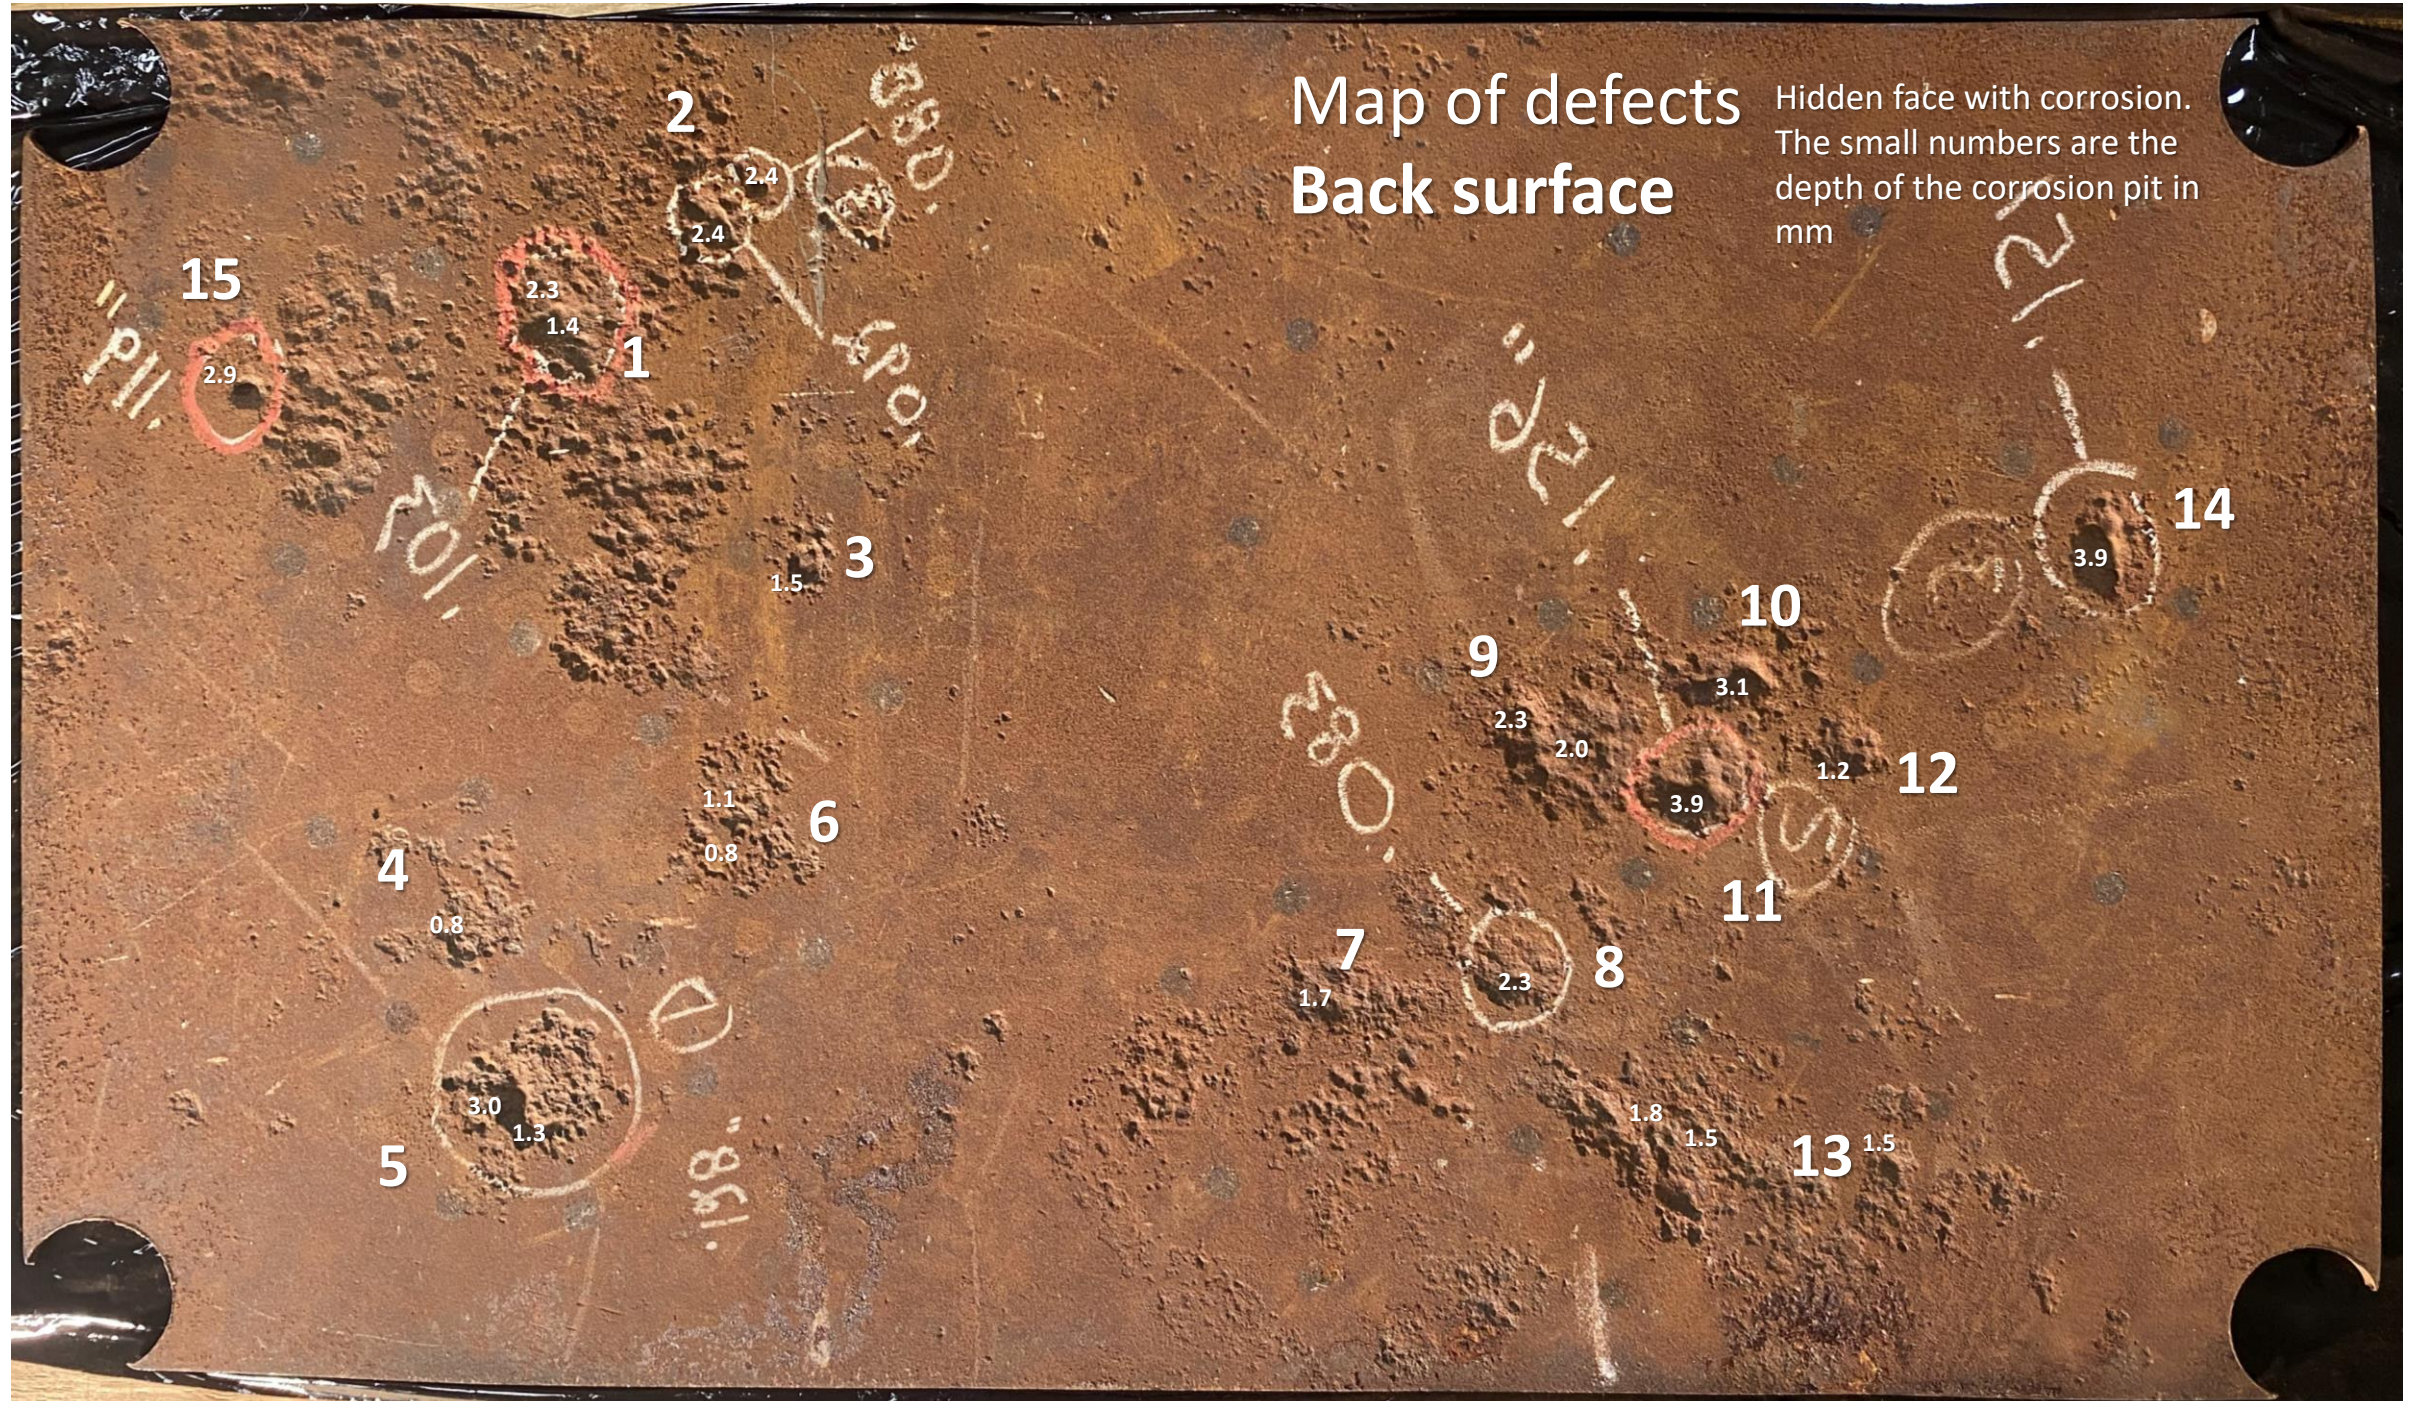
Map of defects Back surface

Hidden face with corrosion.
The small numbers are the
depth of the corrosion pit in
mm

Letters = front paint defects
Numbers = back corrosion defects
Image is inverted to compare
against the previous picture
